University of Ljubljana Academy of Fine Arts

Miladi Makuc Semion **Ambient** M1 by Vinko Tušek – construction dilemmas **43 years later**

THE GLASGOW SCHOOLSARE Authenticity in Transition: Changing Practices in Contemporary Art Making and Conservation Glasgow, 1 and 2 December 2014

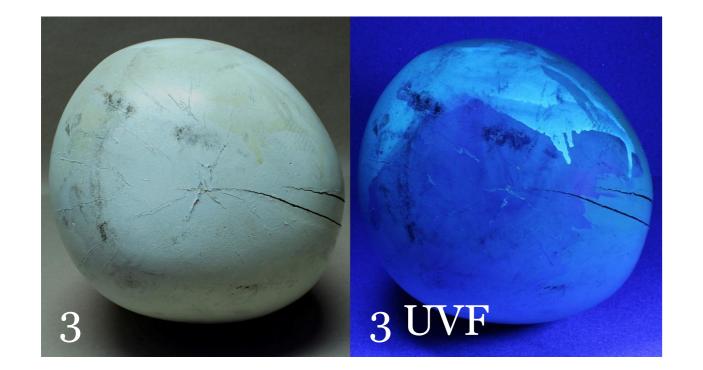
The bigger elements are of irregular, organic forms and most likely made of lime wood. Due to the shrinkage of the wood deep radial cracks appeared. The smaller components are round or oval, made on a lathe and most likely of beech wood. The paint layer is relatively well preserved despite minor flaking. There is a significant difference in the texture and thickness of the colour coating: bigger elements were coated by spraying, smaller with a brush. The sprayed paint layers are thin and slightly rough. In the case of hand-painted elements the paint layer is thick and shiny. According to the artist's son Marko, Tušek used car and nitro lacquers. The elements were finally coated with transparent varnish, which is now unevenly yellowed. The iron elements (diameter 3-12 mm), were painted with a once white paint for metal. The paint was darkened and damaged in several places, minor oxidation was present.

Fig. 1 - Ambient M1 in the year 1971 *Fig. 2 – Dismantled elements before treatment* Fig. 3 - 7 – Typical damages and changes Fig. 8 – Ambient M1 after conservation treatment, Bežigrad Gallery 2, Ljubljana, 24 April 2014 Photographs: 1 – Archive MG+MSUM, 2 - 8 – Miladi Makuc Semion

Due to lack of time and resources detailed analyzes have not been performed. For an overview of the state of the surface, we used UV fluorescence. The elements were cleaned with erasers, white spirit, Triammonium citrate (2%), and distilled water. The original varnish, although partly yellowed, was preserved. The flaking layers were treated with Medium for consolidation Lascaux 4176 and the heating spatula. Radial cracks were closed with inlays of Balsa wood and putty (Klucel G, Arbocel BC 200), the levels were equalized with gesso (Klucel G or glue, Bologna chalk). The inpaintings were made with acrylic paints (Liquitex). Where necessary, we achieved a gloss by applying a thin coat of Gum Arabic.
