THE CONSERVATION AND RELOCATION OF A MONUMENTAL PETRACHROME MURAL: HELEN LUNDEBERG'S *THE HISTORY OF TRANSPORTATION*

Rosa Lowinger and Andrea Morse

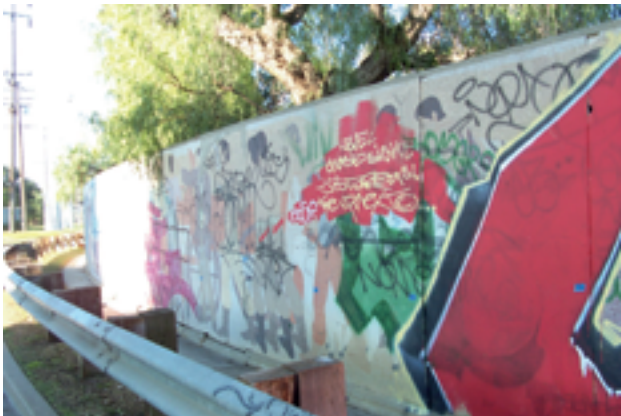
Fig. 2 The middle section of the mural before treatment, covered in graffiti at Vincent Edward Jnr Park.

Fifteen years after the mural's installation, streetcar lines disappeared in favor of automobile travel, and the freeway system drew travelers away from previously established street routes. Florence Avenue, once the bustling major artery that connected the downtown area to the port of Los Angeles, soon became a little-used, semi-abandoned thoroughfare. Trees grew up and around the mural, obscuring its appearance and cracking its foundation wall. Fewer and fewer people noticed the piece from the street. Minor cracking, which could have been easily mitigated, was allowed to expand, and large and small fragments began to fall from numerous panels. The mural also sustained damage, getting hit by forklifts moving caskets at a vault company that abutted the support wall on the back, and on two occasions, by automobiles that jumped the curb, destroying two panels and severely damaging several others. Worst of all, Vincent Edward Park became a hotly-contested street gang territory, turning the mural into a platform for regularly-applied graffiti (Fig. 2).

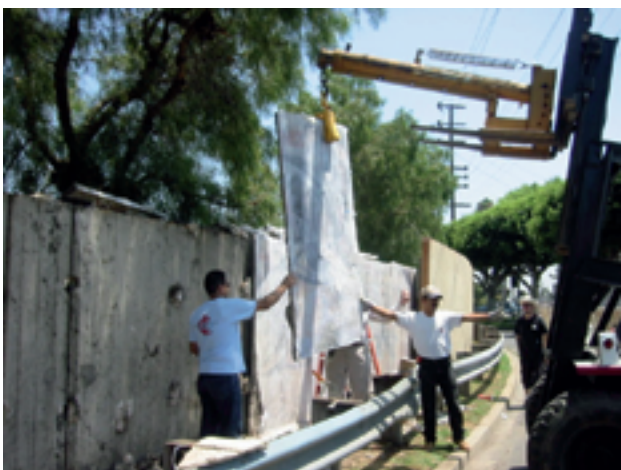
Fig. 3 De-installation of the mural, showing texture from wooden moulds on the concrete wall and plaster 'slop' on the wall.

In 1988, a committee of Inglewood citizens convened to decide what to do about this community treasure which was nonetheless an eyesore. By this time, the mural was so marred by graffiti that 30% of the design was completely obscured by spray paint and magic marker (Fig. 3). These initial efforts to save the mural failed due to a lack of funding. The matter was not taken

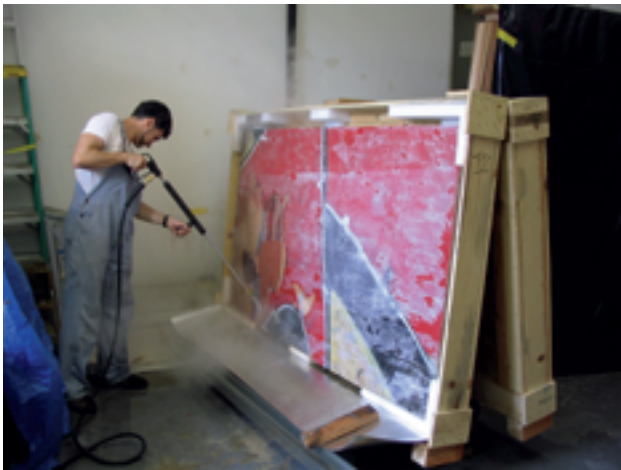
Fig. 4 Power washing to remove graffiti.

In-studio conservation began with removal of the facing and the graffiti (Fig. 4). The panels were brushed with a commercial paint stripper and cleaned with hot pressurized water at 2–4 times atmospheric pressure. Careful monitoring was undertaken to insure that the water pressure and distance were kept at even levels so the petrachrome would not be marred. This process, repeated several times, successfully removed the facing and 80–90% of the graffiti. However, because it had been applied over so many years, multiple layers of paint had seeped into the porous structure of the petrachrome. Microscopical examination⁴ revealed that there was no longer any resinous paint binder, but that the pigments from the graffiti were lodged in the pore structure, and were insoluble in both organic solvents and alkaline cleaning agents (Fig. 5).

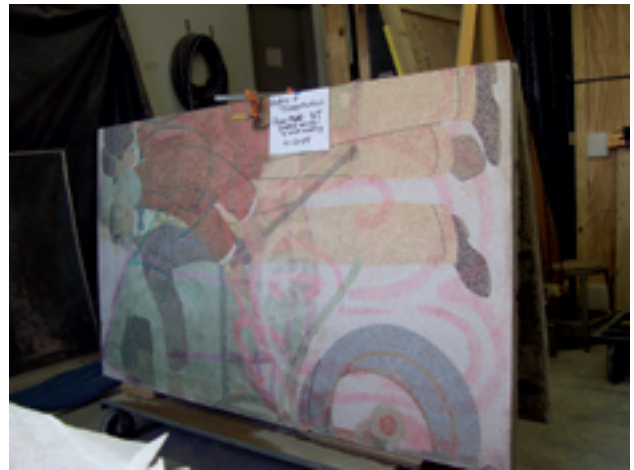
Fig. 5 Panel #25, showing insoluble graffiti ghosting that required removal by powder blasting, and texture of petrachrome.

examination had indicated that the pigment was close to the surface, i.e. it was not deeply bound into the pore structure. Because most, if not all of the pigment particles were softer than the surrounding silica from which the petrachrome substrate was composed, abrasive blasting of this nature could be carried out successfully. Tests indicated that aluminum oxide was the most effective and least abrasive method for removal of the graffiti 'ghosting'. The treatment was carried out on all the affected panels, and followed by a final cleaning with acetone and hot pressurized water.

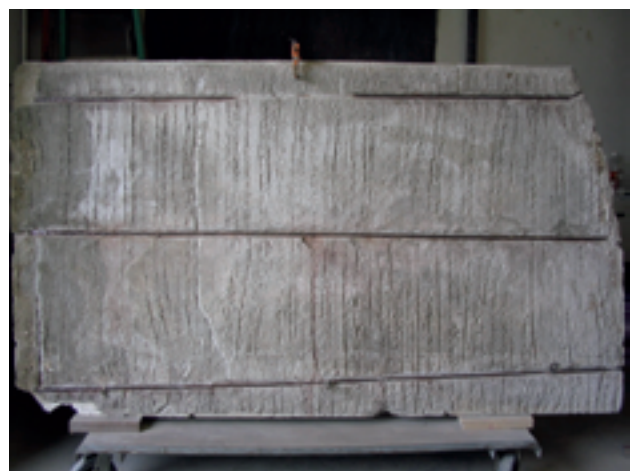
Fig. 6 Panel #59, showing exposed rebar supports before treatment.

A key aspect of this project involved compliance with OHP guidelines. As one of the chief funders of the project, OHP required SCS to submit protocols for all steps in the conservation treatment for their prior approval. Because the reviewers were not conservators or trained in conservation, this process often led to lively discussions about processes and intended outcome. One of the initial areas of concern on the part of OHP was in the repairs to the concrete backing. The concrete was riddled with cracks caused by corroding steel rebars (Fig. 6). In many cases, this steel was sufficiently intact to be cleaned and coated with Sikadur 23, a commercial epoxy-based structural adhesive that has been successfully used in a similar capacity on the conservation of the Simon Rodia Towers in Watts, California. The rebar was then covered with a mortar mix that did not exceed the strength of the original. Any rebar that had lost more than 50% of its diameter was replaced. Because the concrete that topped the steel was less than 1 inch (2.5 cm) thick, OHP recommended the use of stainless steel for the replacement rebar. However, it

was evident to the conservators that this could pose problems of galvanic corrosion if the stainless steel made contact with the mild steel chicken wire that was used as reinforcement in the concrete. Support from colleagues made it possible to convince OHP that though mild steel was inherently less stable than stainless, it was the best material for this process.

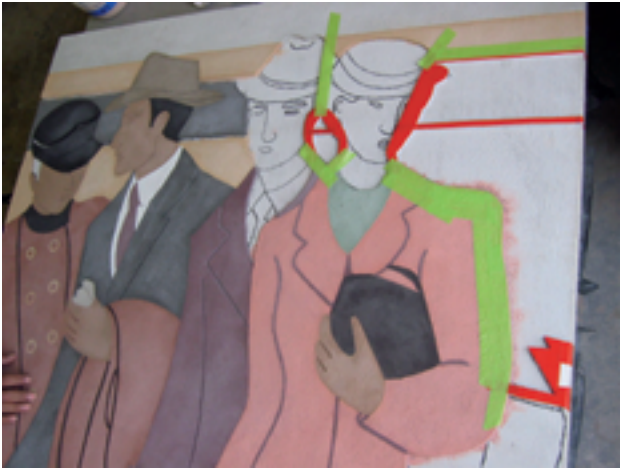
Fig. 7 Fabrication of new replacement panel using colored Jahn M-90 mortar.

Another area of debate was the choice of fill material for missing areas of petrachrome. Funding for the project did not allow for significant analysis to determine the composition of all the aggregate used in each section. Lundeborg's process was idiosyncratic and therefore not easily reproducible without such analysis. This meant that the match would have been done by guesswork and more than likely would have looked like a poor imitation of the original. Because the conservators were also attentive to the ethics of trying to recreate the petrachrome, especially where large sections of loss were concerned, the treatment proposal was to recreate losses using pigmented cement mortar that matched the surrounding petrachrome. The result would provide readability without compromising ethics. Test areas were created using custom-colored Jahn M-90 Mortar, a textured pigmented restoration mortar that resembled the base color of the original panels (Fig. 7). From a distance of 5 feet (1.5 m), roughly half the intended viewing distance, the mural would read as a continuous narrative. From close up, textural differences would be easily distinguishable from the original. Samples of this were approved by a committee from the City of Inglewood and, ultimately, after much discussion, by OHP. Once these repairs and fills were completed, the overall image regained its narrative unity, allowing it to be clearly read by the viewing public.

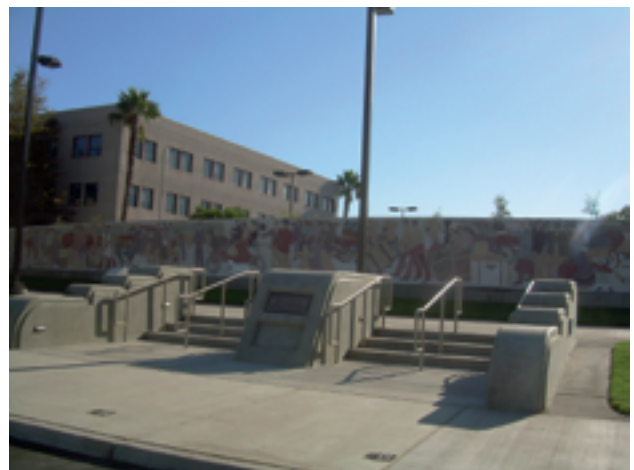
Fig. 8 The mural after conservation, installed on new wall at Grevillea Art Park.

The final area of concern in this treatment was the preparation of the new support wall at the Grevillea Park site. As mentioned above, the original support wall was a convex-curved structure designed for the original site and fabricated by pouring in place into wooden moulds. The new site was situated next to an assisted living complex for senior citizens and there was concern that the mural would obscure the entryway in a manner that was not in keeping with city codes. The city proposed to mitigate this by changing the shape of the retaining wall from a convex curve to an undulating curve that would be shorter in overall length, and not obscure the entryway. OHP did not accept this solution. Because the original wall was part of Lundeborg's commission, and because it was deliberately finished with bull nose ends and a 1 inch (2.5 cm) cap on top, it was considered an unalterable component of the design. A rubble-filled concrete block wall had been proposed for the replacement, but OHP also insisted on the wall's fabrication by the original poured-in-place method, using moulds that would provide the original wood texture to the reverse side. Though such a wall was far more complex and expensive to fabricate, in the end this is what was done. The city accommodated the shape issues by shifting the position of the wall and mural to avoid blocking the entry to the senior center. The wall was poured in place by contractors hired by the city to construct the hardscaping at the newly named Grevillea Art Park. The mural was hung by C&L under the supervision of SCS, using a variation on the original method employed, but substituting exterior-grade mortar for the original 'slop'. The last stages in treatment were the application of the anti-graffiti coating and the grouting of the joins between panels.
