University of Ljubljana Academy of Fine Arts

Miladi Makuc Semion **Ambient** M1 by Vinko Tušek – construction dilemmas **43 years later**

THE GLASGOW SCHOOLSARE Authenticity in Transition: Changing Practices in Contemporary Art Making and Conservation Glasgow, 1 and 2 December 2014

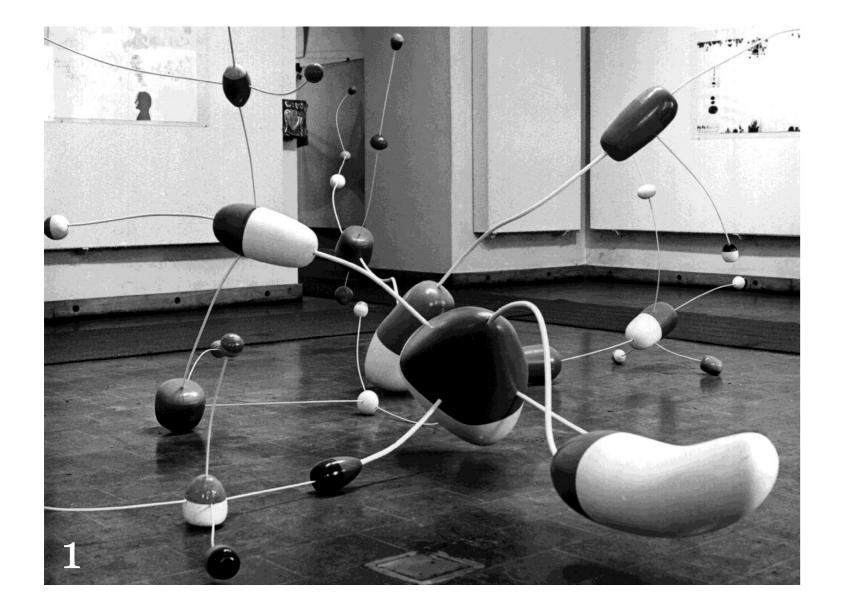
Fig. 1 - Ambient M1 in the year 1971 *Fig. 2 – Dismantled elements before treatment* Fig. 3 - 7 – Typical damages and changes Fig. 8 – Ambient M1 after conservation treatment, Bežigrad Gallery 2, Ljubljana, 24 April 2014 Photographs: 1 – Archive MG+MSUM, 2 - 8 – Miladi Makuc Semion

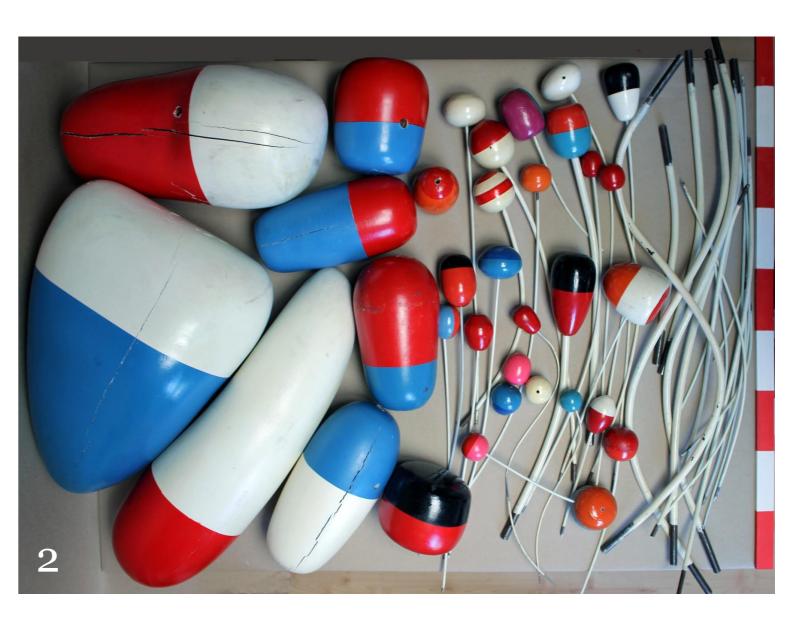
The bigger elements are of irregular, organic forms and most likely made of lime wood. Due to the shrinkage of the wood deep radial cracks appeared. The smaller components are round or oval, made on a lathe and most likely of beech wood. The paint layer is relatively well preserved despite minor flaking. There is a significant difference in the texture and thickness of the colour coating: bigger elements were coated by spraying, smaller with a brush. The sprayed paint layers are thin and slightly rough. In the case of hand-painted elements the paint layer is thick and shiny. According to the artist's son Marko, Tušek used car and nitro lacquers. The elements were finally coated with transparent varnish, which is now unevenly yellowed. The iron elements (diameter 3-12 mm), were painted with a once white paint for metal. The paint was darkened and damaged in several places, minor oxidation was present.
